**EFFECTS OF ENVIRONMENT ON CREEP BEHAVIOR OF
NEXTEL720/ALUMINA-MULLITE CERAMIC COMPOSITE
WITH $\pm 45^\circ$ FIBER ORIENTATION AT 1200°C
THESIS**

AFIT/GSS/ENY/09-M05

**DEPARTMENT OF THE AIR FORCE
AIR UNIVERSITY**

Degree of Master of Science (Space Systems)

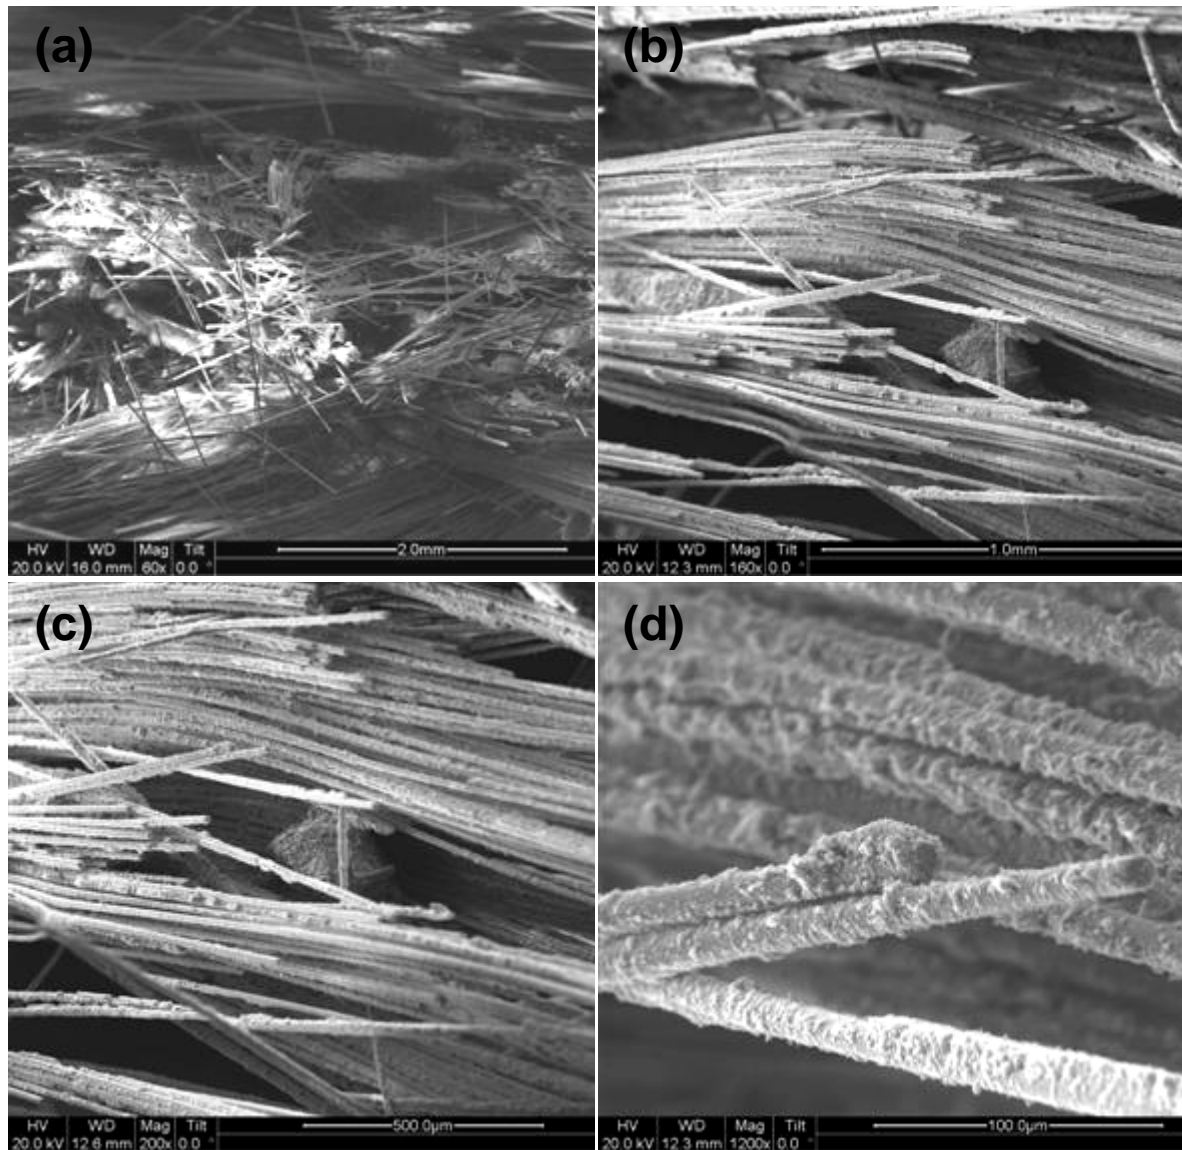
Figure 54. SEM micrograph of the fracture surface of the N720/AM specimen with $\pm 45^\circ$ fiber orientation subjected to tensile test to failure with a constant stress rate of 25 MPa/s at 1200°C in laboratory air.

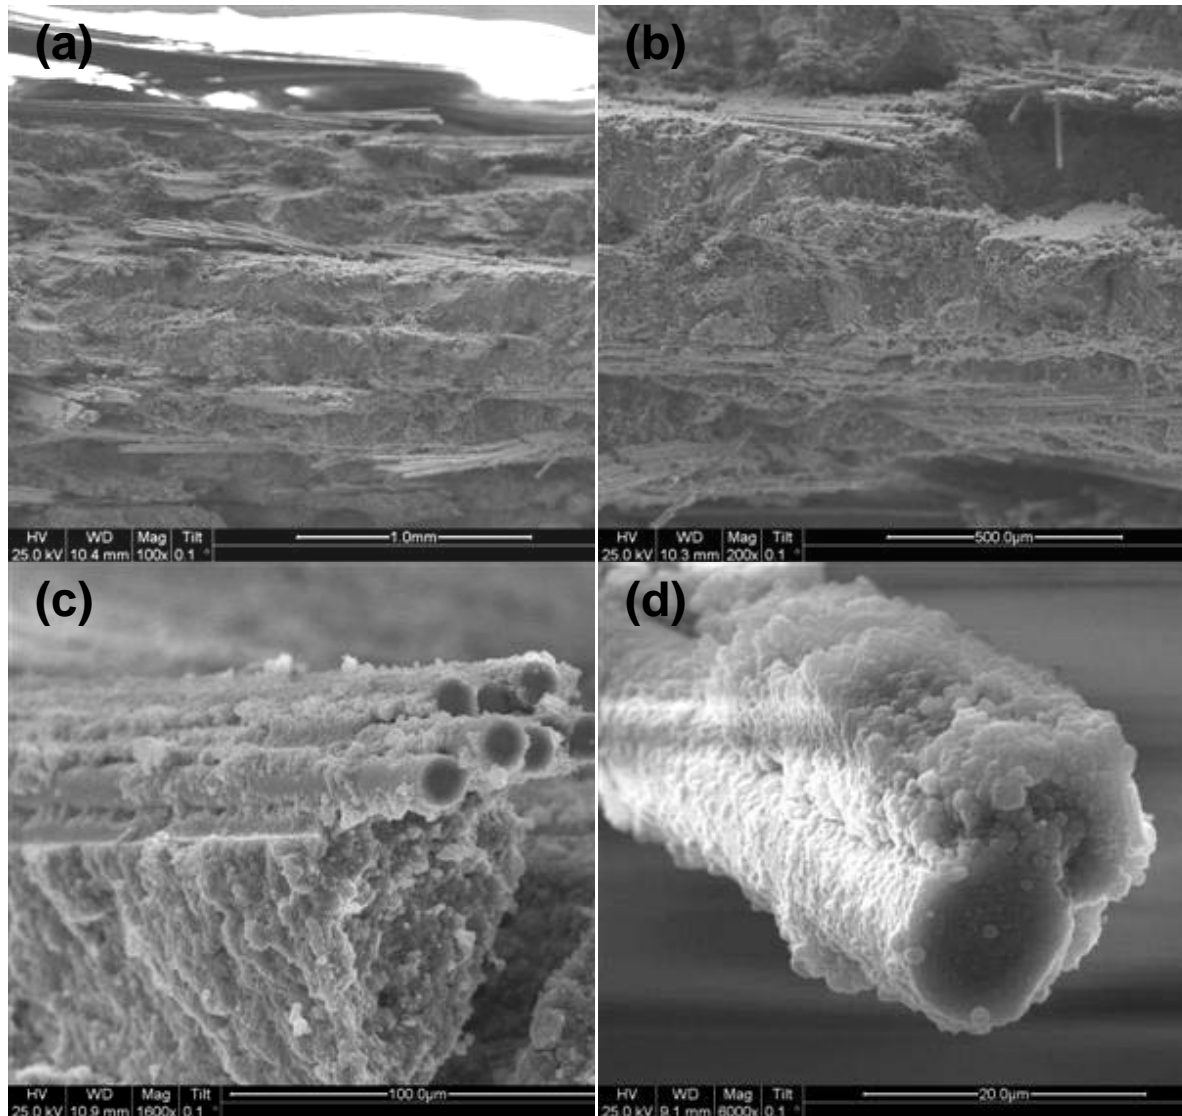
Figure 55. SEM micrograph of the fracture surface of the N720/AM specimen with $\pm 45^\circ$ fiber orientation subjected to tensile test to failure with a constant stress rate of 0.0025 MPa/s at 1200°C in steam.

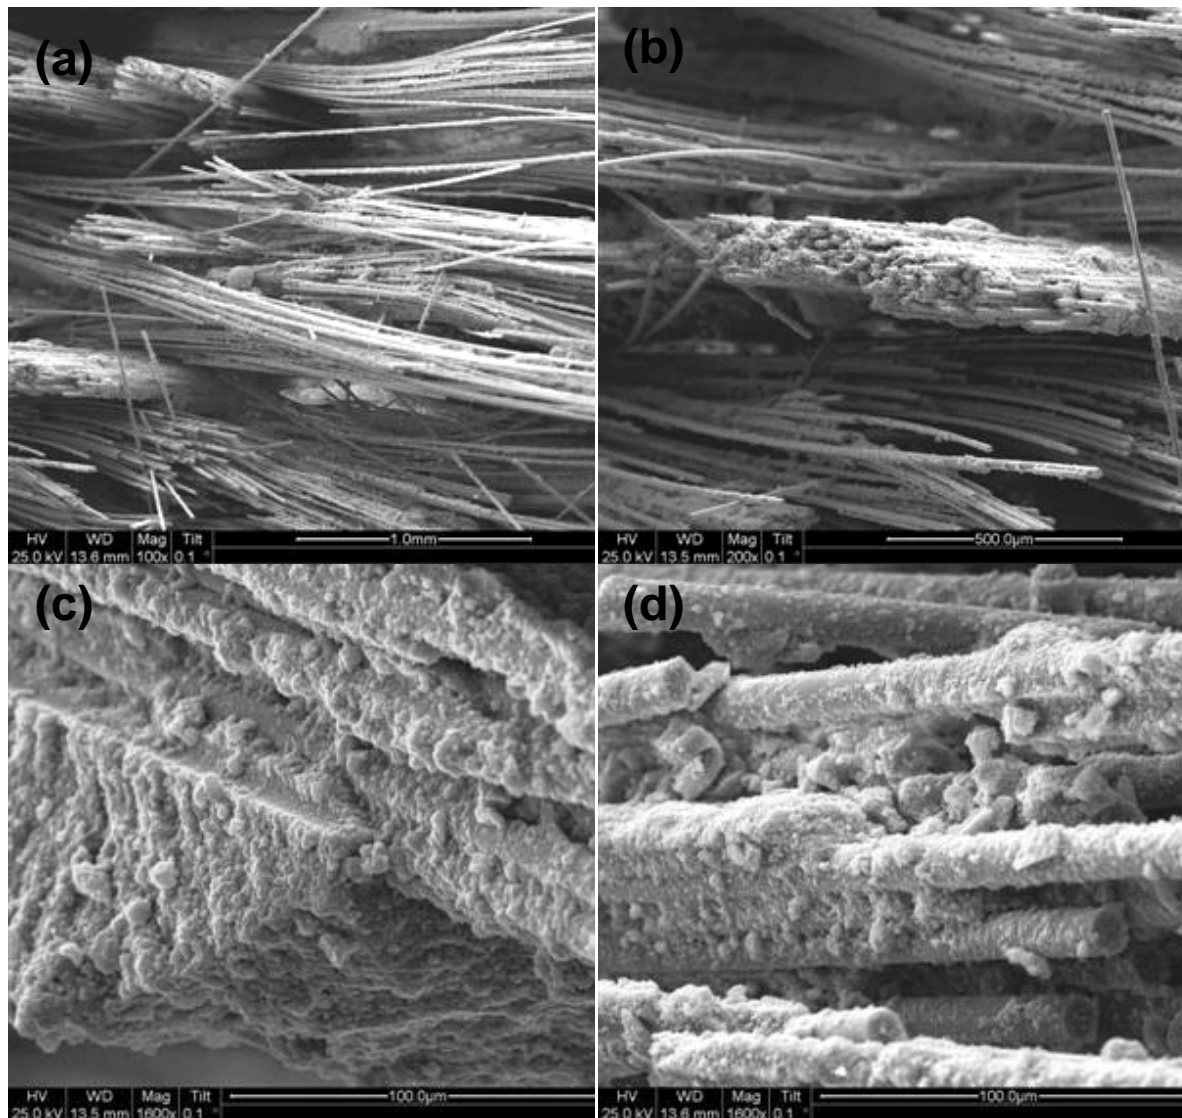
Figure 56. SEM micrograph of the fracture surface of the N720/AM specimen with $\pm 45^\circ$ fiber orientation subjected to tensile test to failure with a constant stress rate of 25 MPa/s at 1200°C in steam.

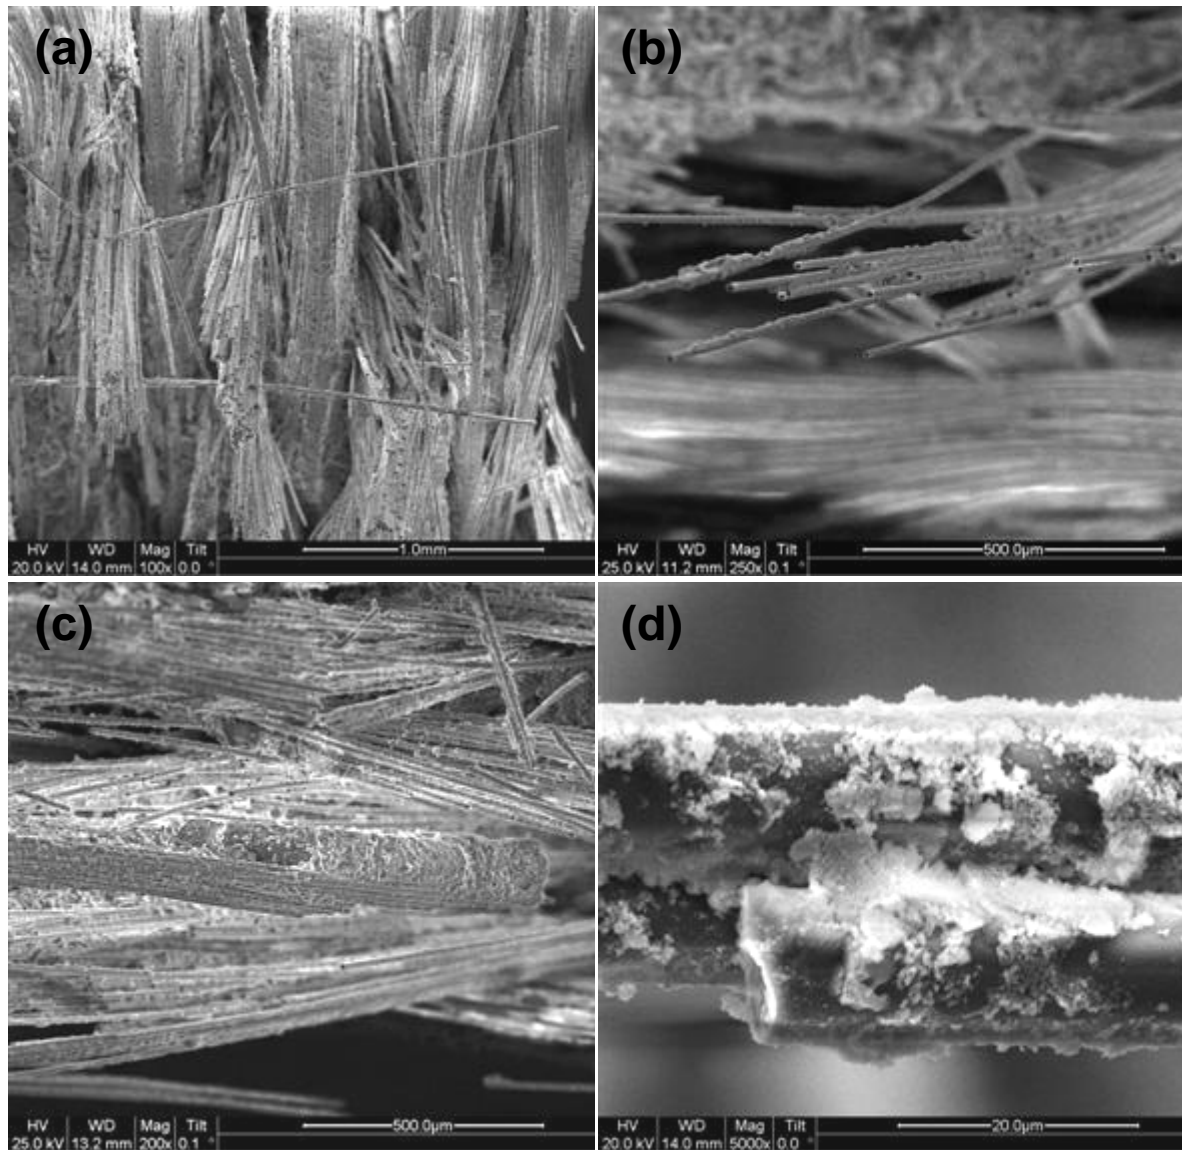
Figure 57. SEM micrograph of the fracture surface of the N720/AM specimen with $\pm 45^\circ$ fiber orientation subjected to displacement controlled (0.05 mm/s) monotonic tensile test to failure at 1200°C in laboratory air, $t_f = 0.0007$ h.

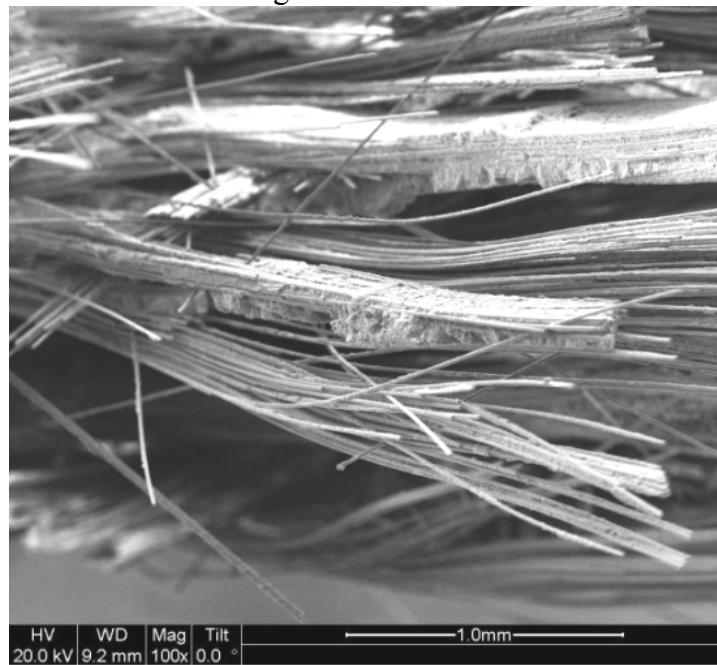
Figure 63. SEM micrograph of the fracture surface of the N720/AM specimen subjected to tensile test to failure following 100 h at 13 MPa at 1200°C in laboratory air.

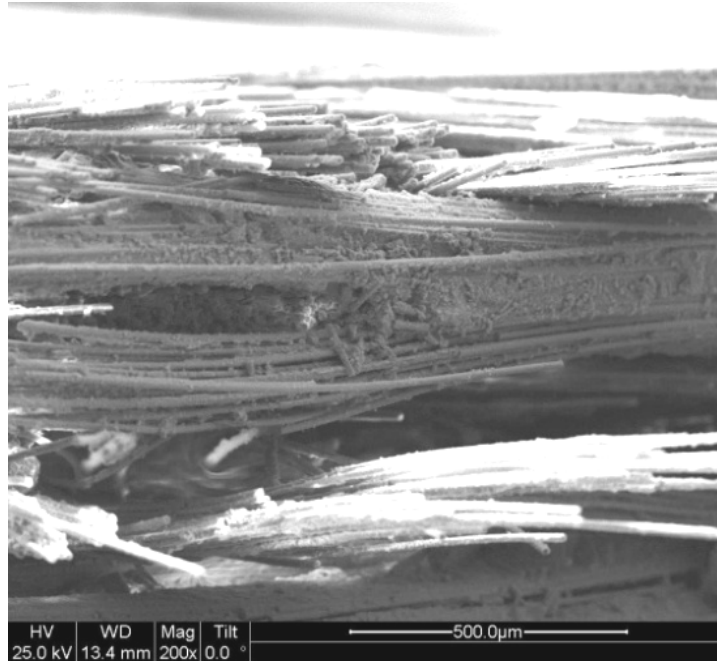
Figure 102. SEM micrograph of the fracture surface of the N720/AM specimen subjected to tensile test to failure following 100 h at 30 MPa at 1200°C in laboratory air.

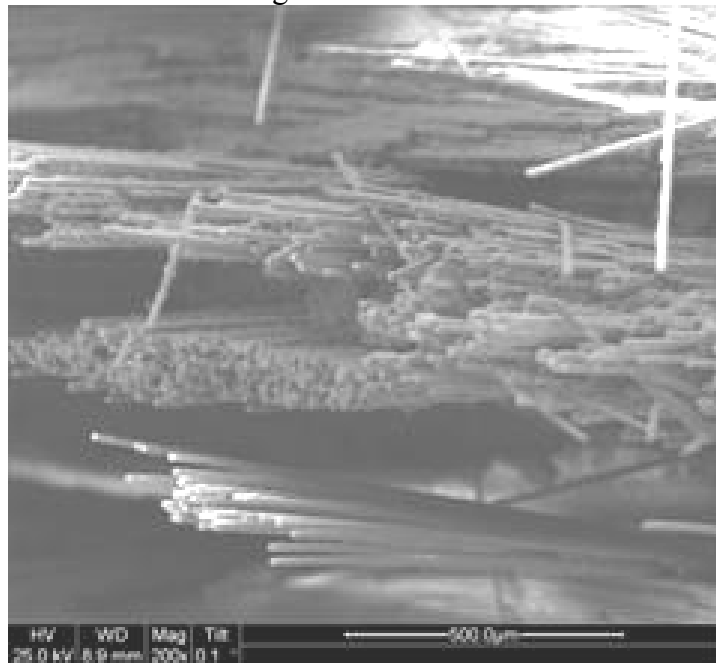
Figure 159. SEM micrograph of the fracture surface of the N720/AM specimen subjected to tensile test to failure following 100 h at 32 MPa at 1200°C in laboratory air.

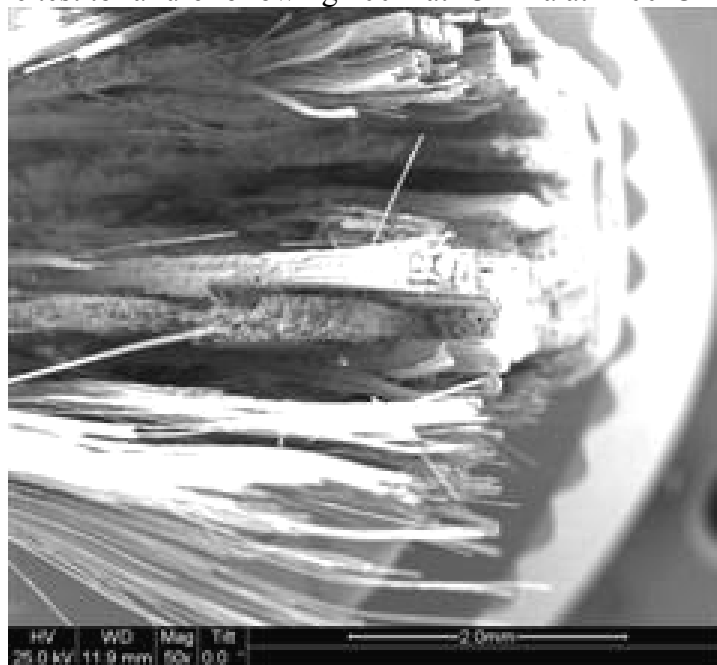
Figure 187. SEM micrograph of the fracture surface of the N720/AM specimen subjected to tensile test to failure following 100 h at 13 MPa at 1200°C in steam.

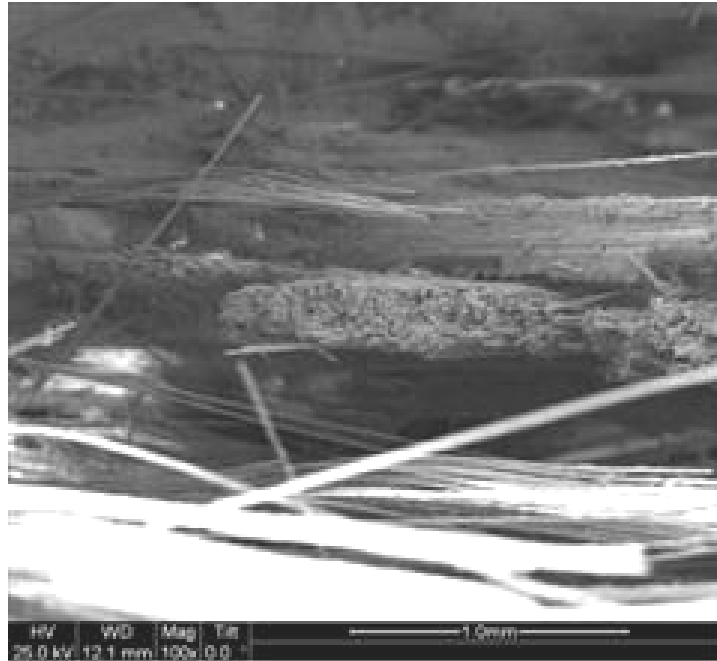
Figure 202. SEM micrograph of the fracture surface of the N720/AM specimen subjected to tensile test to failure following 100 h at 13 MPa at 1200°C in steam.

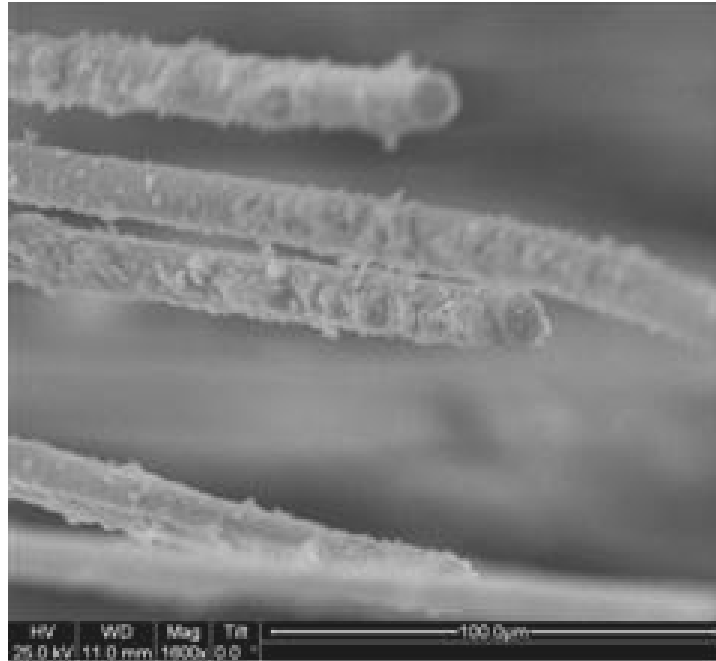
Figure 236. SEM micrograph of the fracture surface of the N720/AM specimen with $\pm 45^\circ$ fiber orientation obtained in creep test conducted at 30 MPa at 1200°C in steam. Creep lifetime $t_f = 1.08$ h.

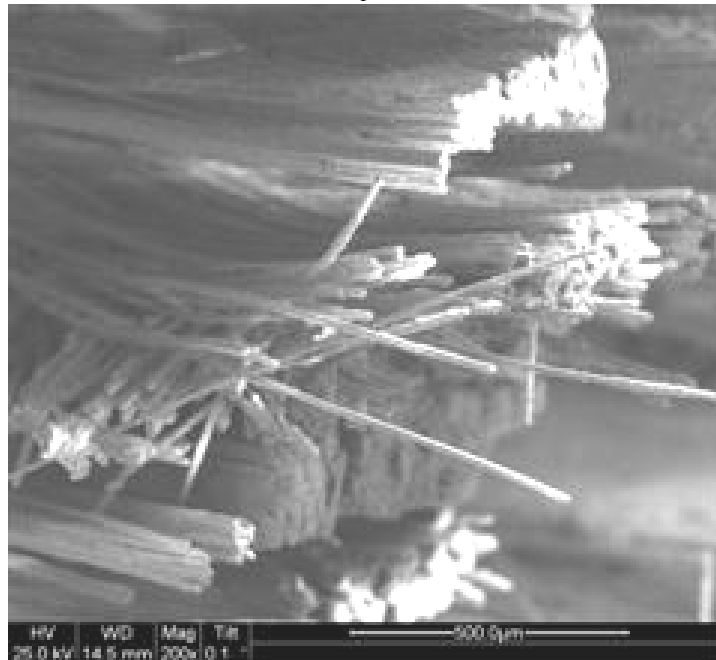
Figure 281. SEM micrograph of the fracture surface of the N720/AM specimen with $\pm 45^\circ$ fiber orientation obtained in creep test conducted at 32 MPa at 1200°C in steam. Creep lifetime $t_f = 0.02$ h.

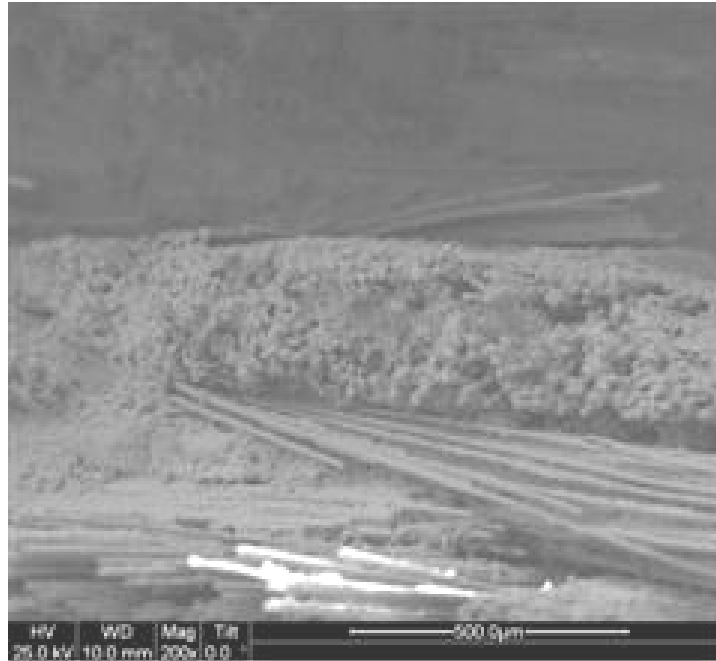
Figure 330. SEM micrograph of the fracture surface of the N720/AM specimen subjected to tensile test to failure following 100 h at 20 MPa at 1200°C in argon.

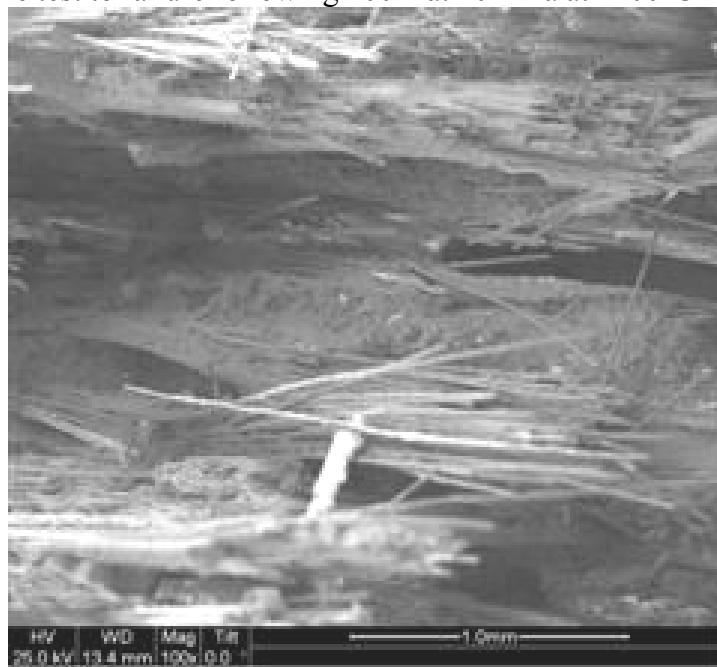
Figure 335. SEM micrograph of the fracture surface of the N720/AM specimen subjected to tensile test to failure following 100 h at 20 MPa at 1200°C in argon.

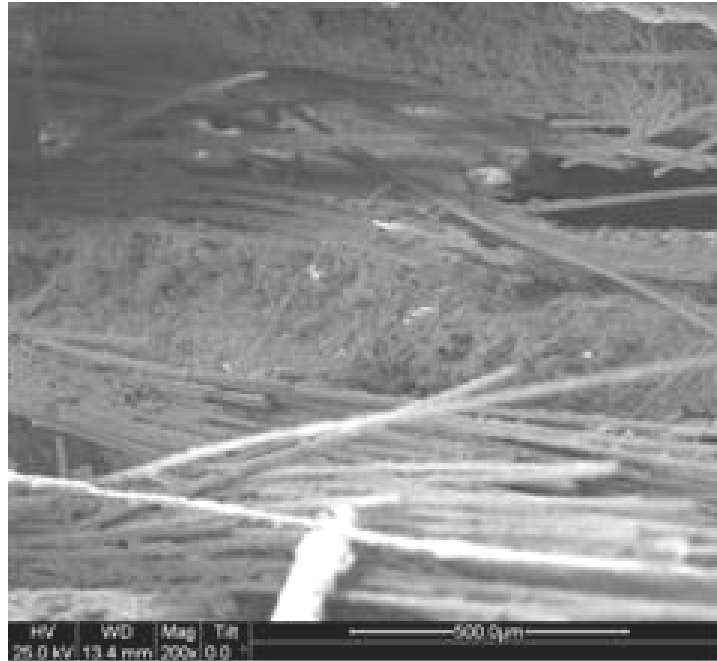
Figure 336. SEM micrograph of the fracture surface of the N720/AM specimen subjected to tensile test to failure following 100 h at 20 MPa at 1200°C in argon.

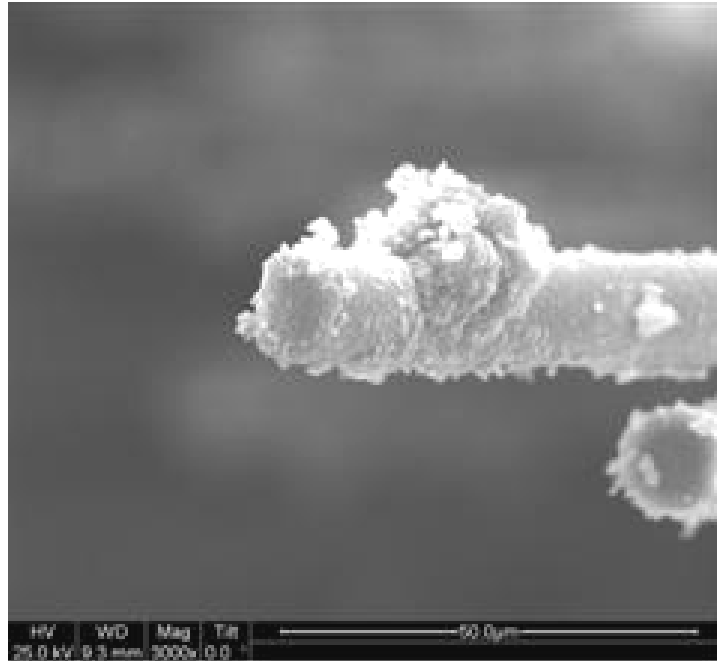
Figure 344. SEM micrograph of the fracture surface of the N720/AM specimen subjected to tensile test to failure following 100 h at 20 MPa at 1200°C in argon.

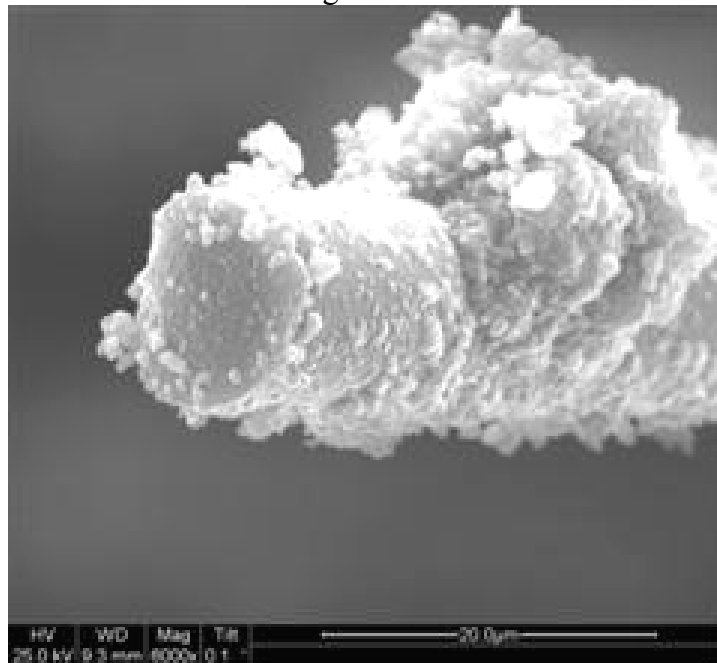
Figure 345. SEM micrograph of the fracture surface of the N720/AM specimen subjected to tensile test to failure following 100 h at 20 MPa at 1200°C in argon.

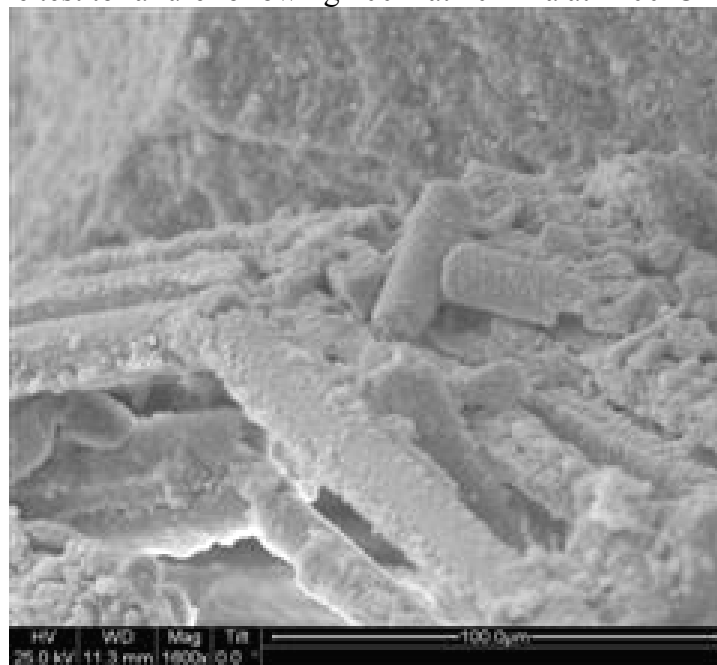
Figure 355. SEM micrograph of the fracture surface of the N720/AM specimen subjected to tensile test to failure following 100 h at 20 MPa at 1200°C in argon.

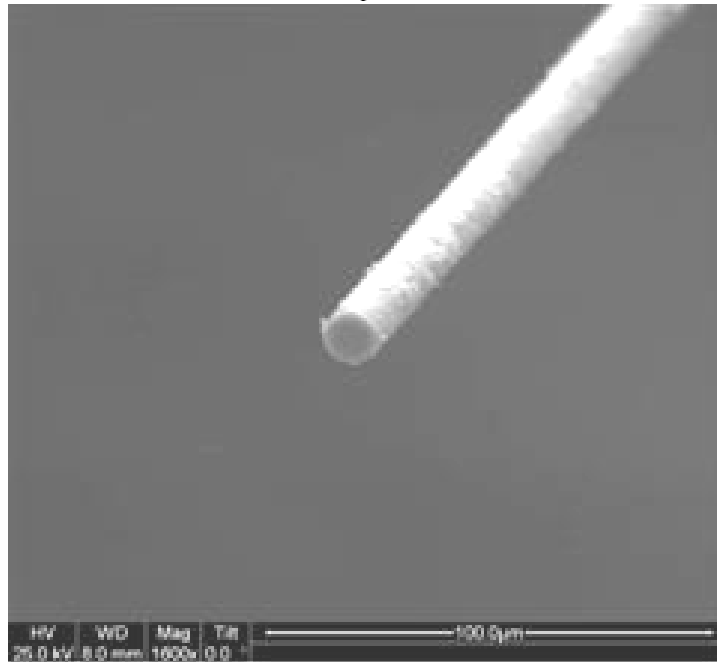
Figure 449. SEM micrograph of the fracture surface of the N720/AM specimen with $\pm 45^\circ$ fiber orientation obtained in creep test conducted at 32 MPa at 1200°C in argon. Creep lifetime $t_f = 0.08$ h.

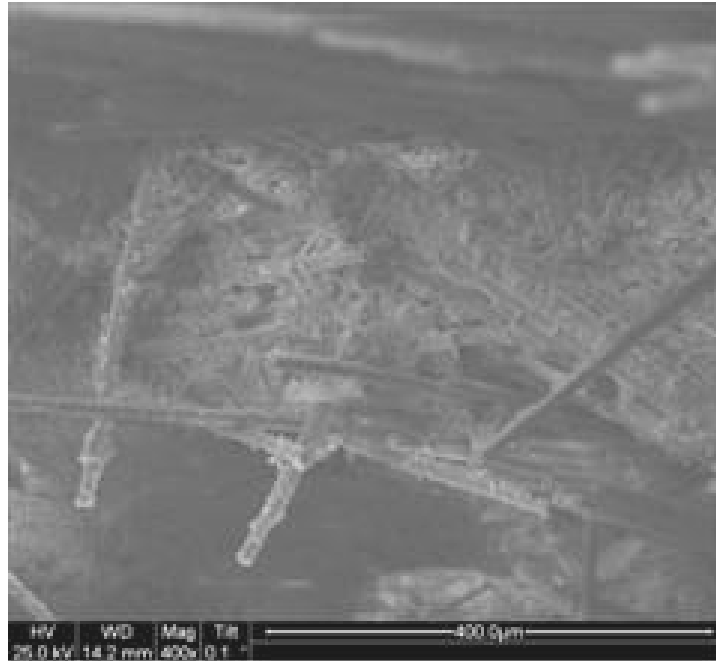
Figure 506. SEM micrograph of the fracture surface of the N720/AM specimen subjected to tensile test to failure with a constant stress rate of 0.0025 MPa/s at 1200°C in laboratory air.

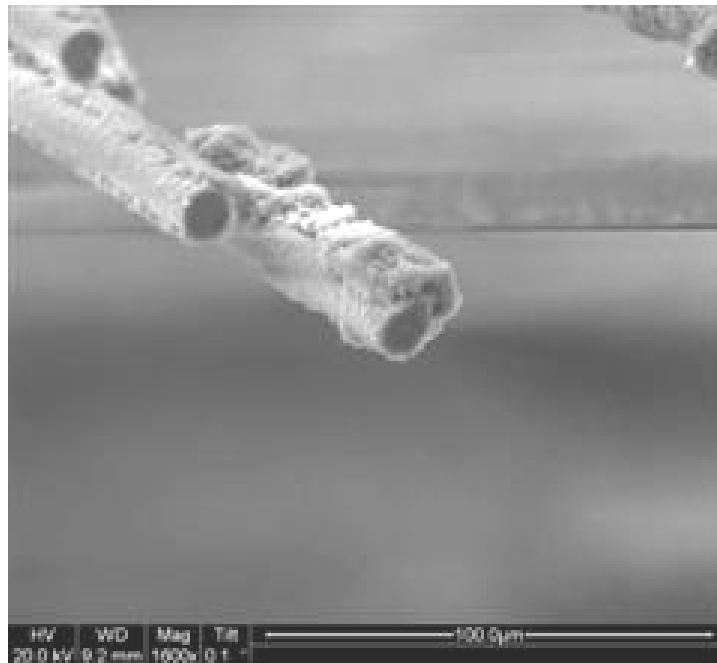
Figure 519. SEM micrograph of the fracture surface of the N720/AM specimen subjected to tensile test to failure with a constant stress rate of 0.0025 MPa/s at 1200°C in steam.

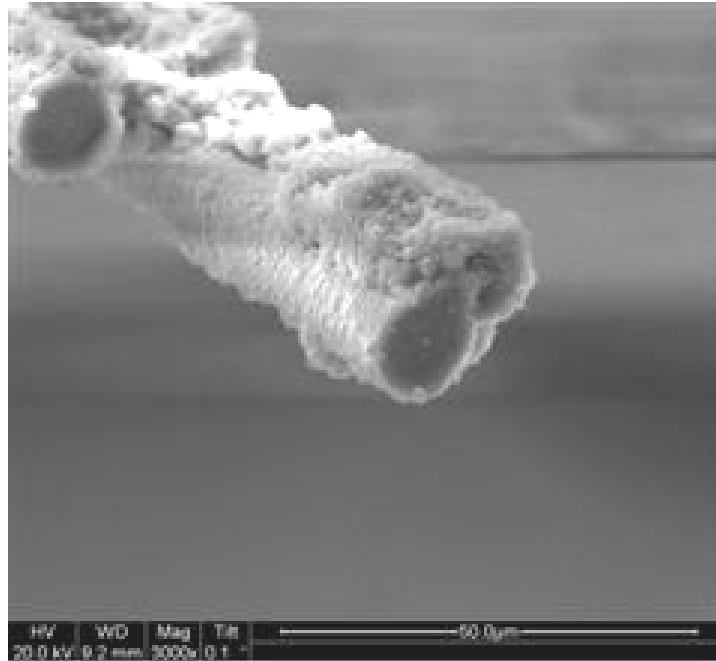
Figure 520. SEM micrograph of the fracture surface of the N720/AM specimen subjected to tensile test to failure with a constant stress rate of 0.0025 MPa/s at 1200°C in steam.

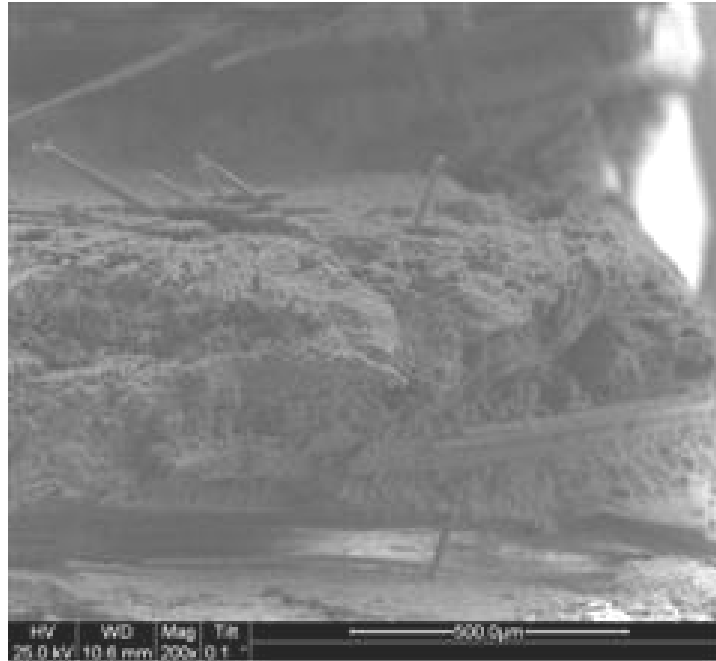
Figure 530. SEM micrograph of the fracture surface of the N720/AM specimen subjected to tensile test to failure with a constant stress rate of 0.0025 MPa/s at 1200°C in steam.

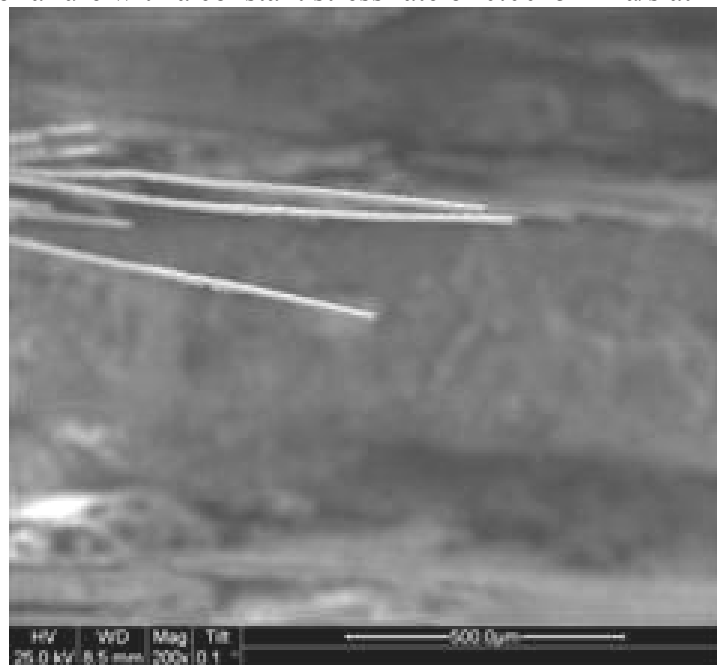
Figure 553. SEM micrograph of the fracture surface of the N720/AM specimen subjected to tensile test to failure with a constant stress rate of 0.0025 MPa/s at 1200°C in steam.

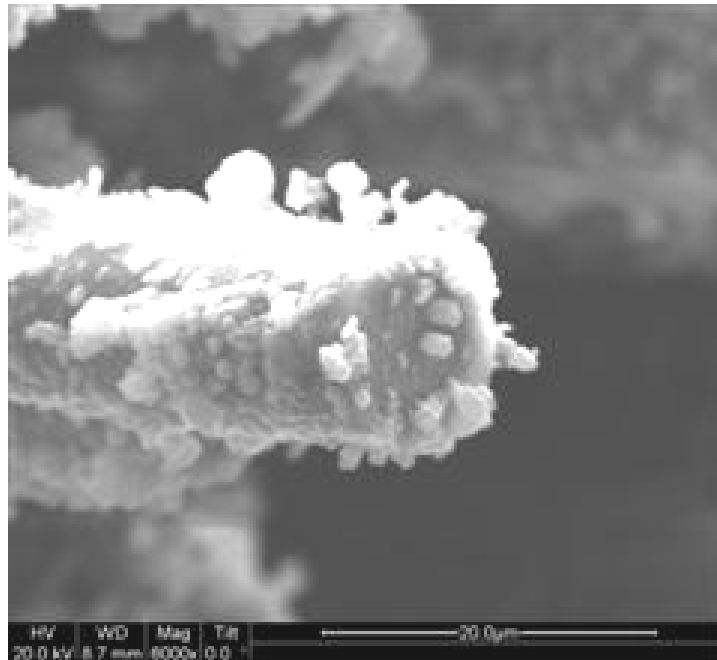
Figure 573. SEM micrograph of the fracture surface of the N720/AM specimen subjected to tensile test to failure with a constant stress rate of 25 MPa/s at 1200°C in laboratory air.

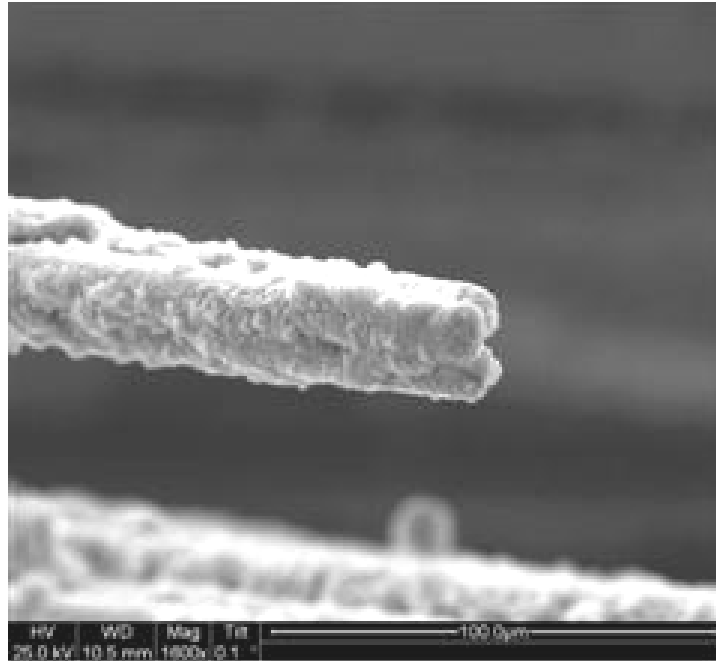
Figure 610. SEM micrograph of the fracture surface of the N720/AM specimen subjected to tensile test to failure with a constant stress rate of 25 MPa/s at 1200°C in steam.

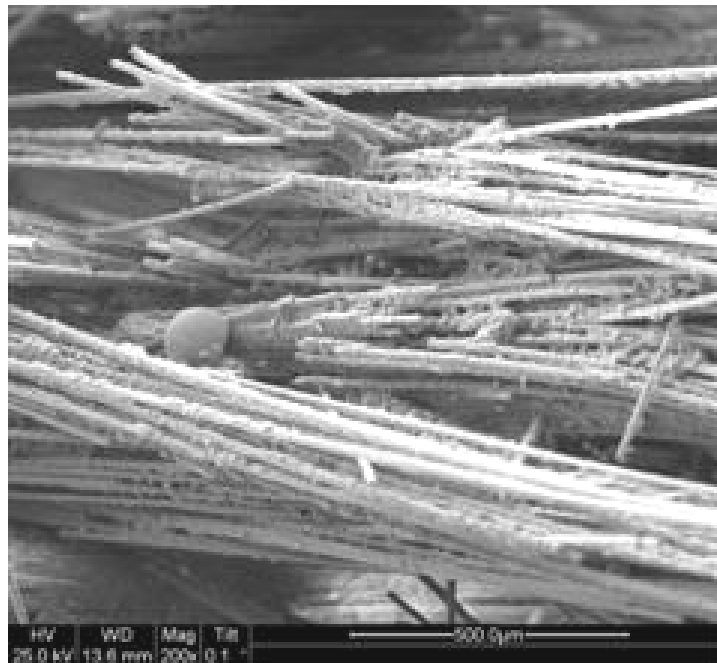
Figure 627. SEM micrograph of the fracture surface of the N720/AM specimen subjected to tensile test to failure with a constant stress rate of 25 MPa/s at 1200°C in steam.

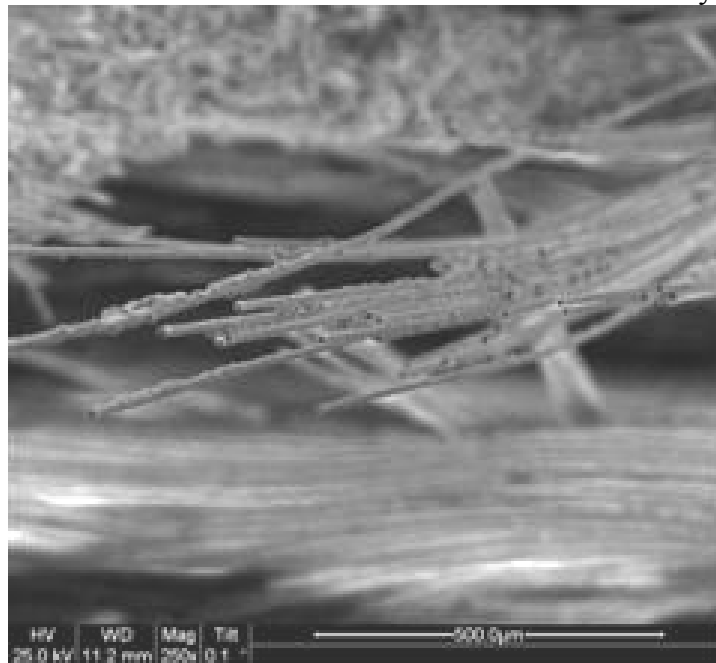
Figure 649. SEM micrograph of the fracture surface of the N720/AM specimen subjected to monotonic tensile test to failure at 1200°C in laboratory air.

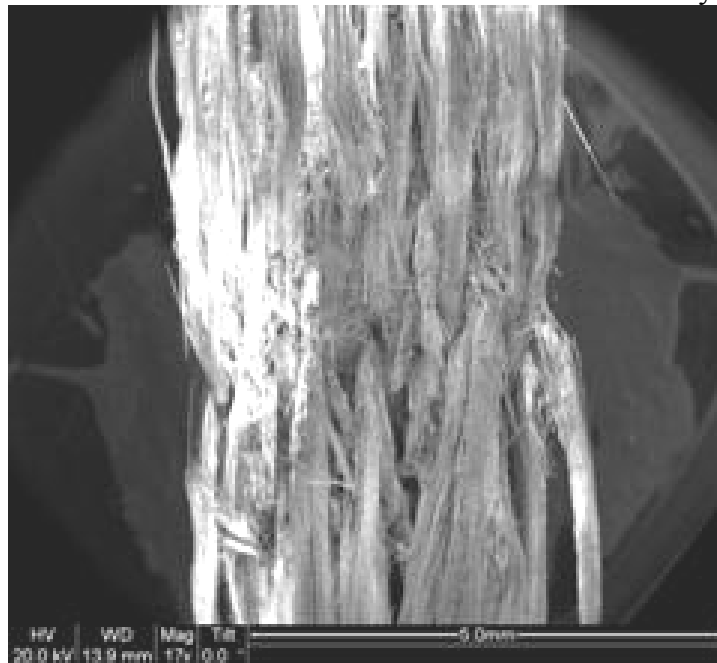
Figure 659. SEM micrograph of the fracture surface of the N720/AM specimen subjected to monotonic tensile test to failure at 1200°C in laboratory air.

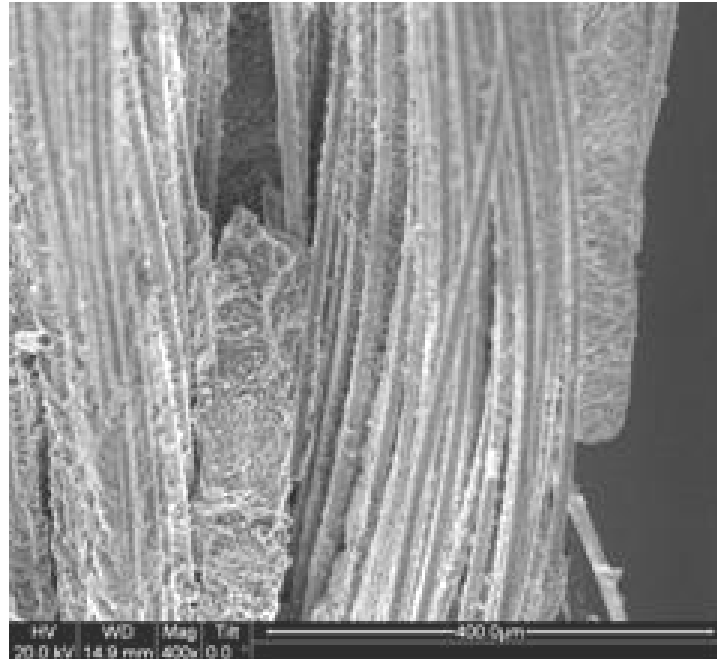
Figure 660. SEM micrograph of the fracture surface of the N720/AM specimen subjected to monotonic tensile test to failure at 1200°C in laboratory air.

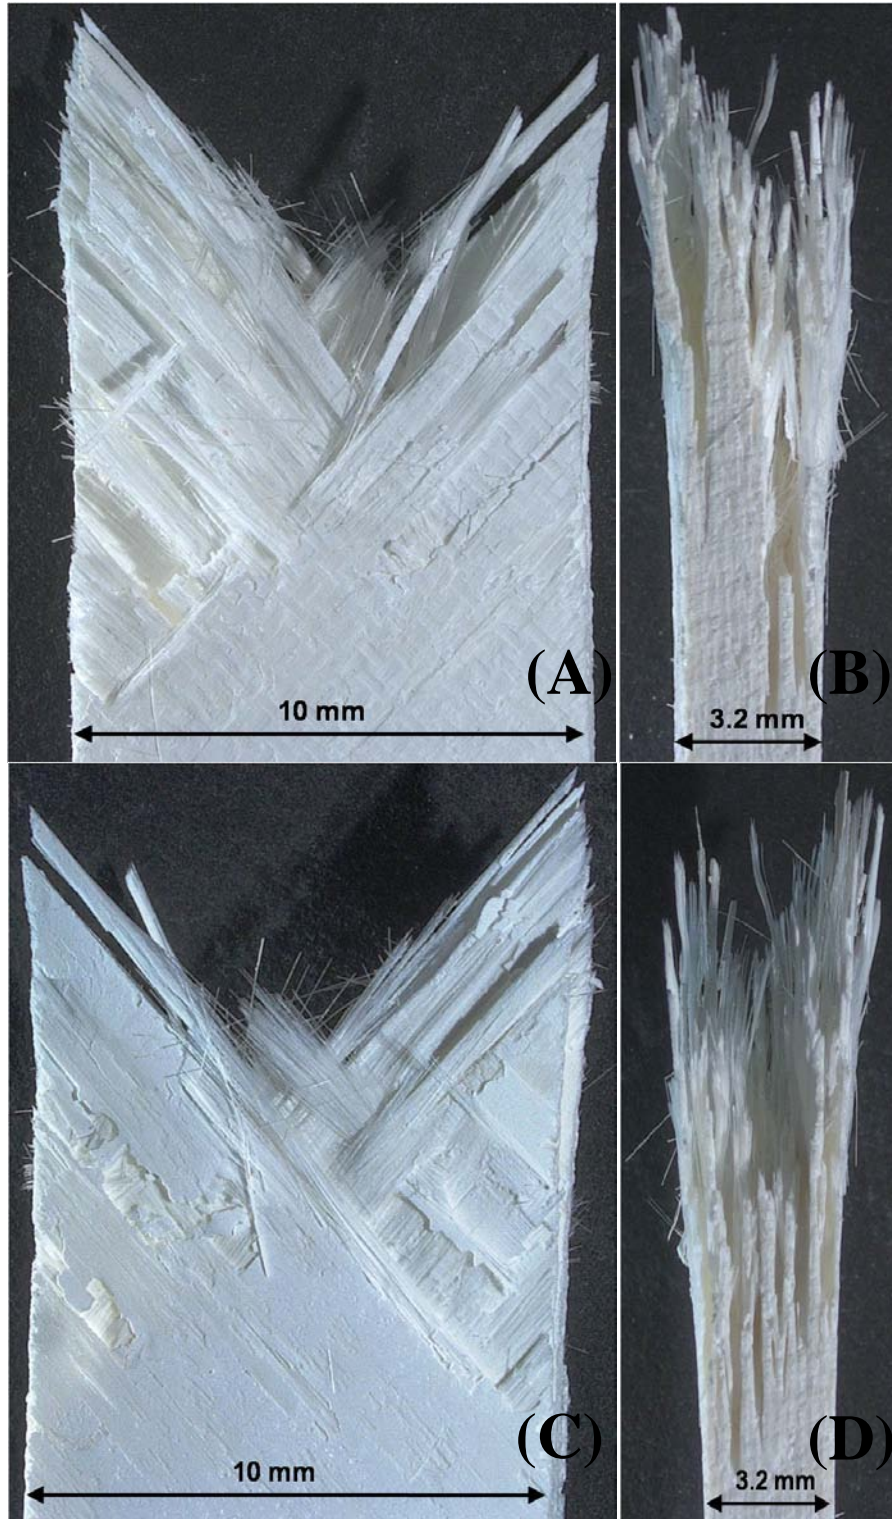
Figure 664. Fracture surface of the N720/AM specimen subjected to tensile test to failure following 100 h at 13 MPa at 1200°C in laboratory air.(a)-(c):front view,(b)-(d):side view

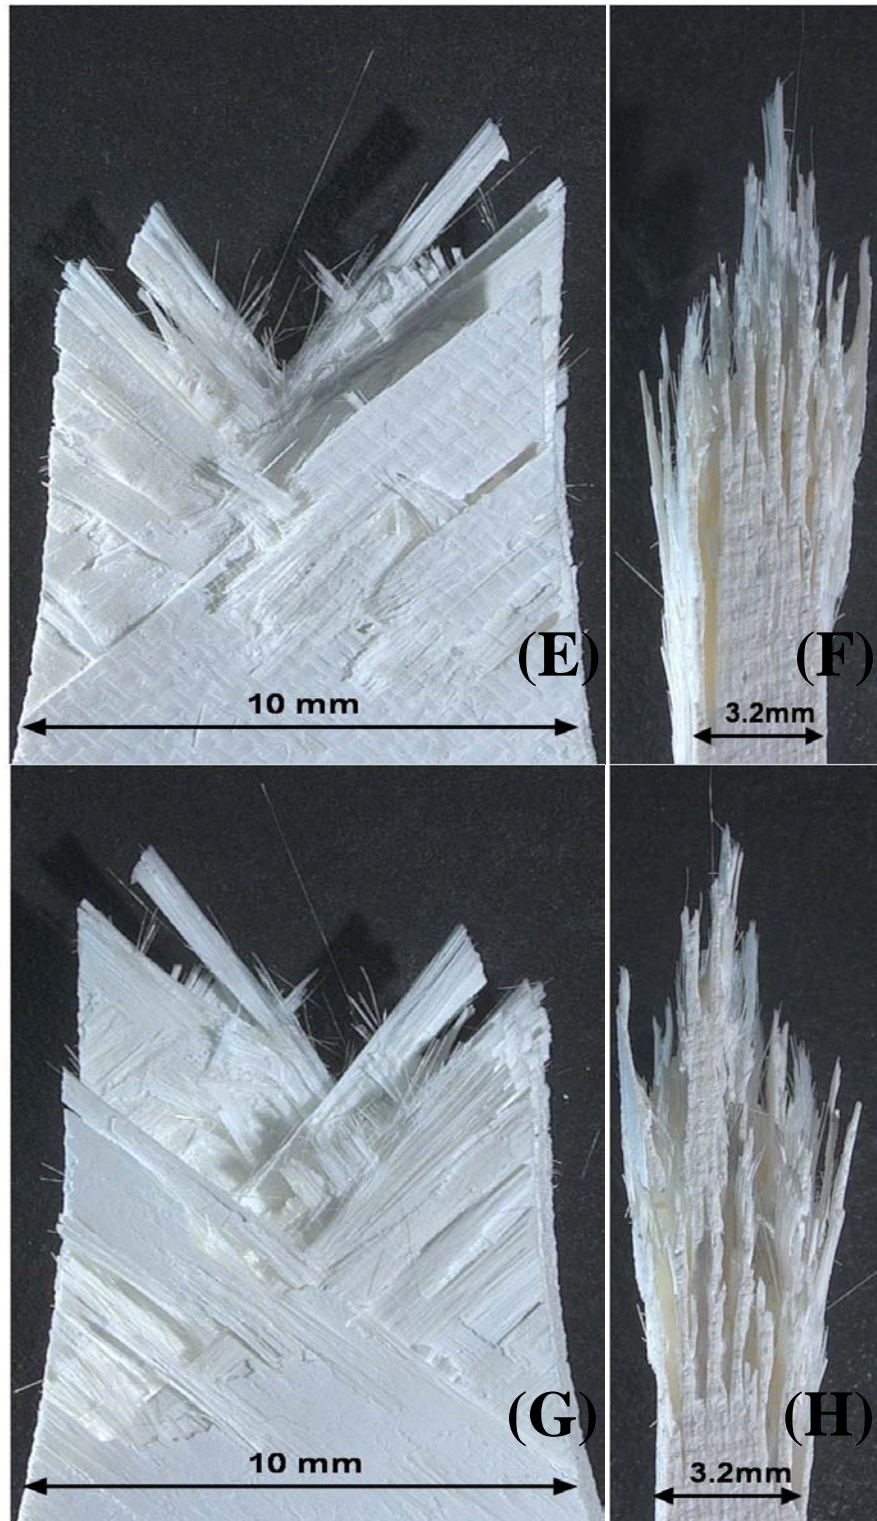
Figure 665. Fracture surface of the N720/AM specimen subjected to tensile test to failure following 100 h at 13 MPa at 1200°C in laboratory air.(e)-(g):front view,(f)-(h):side view

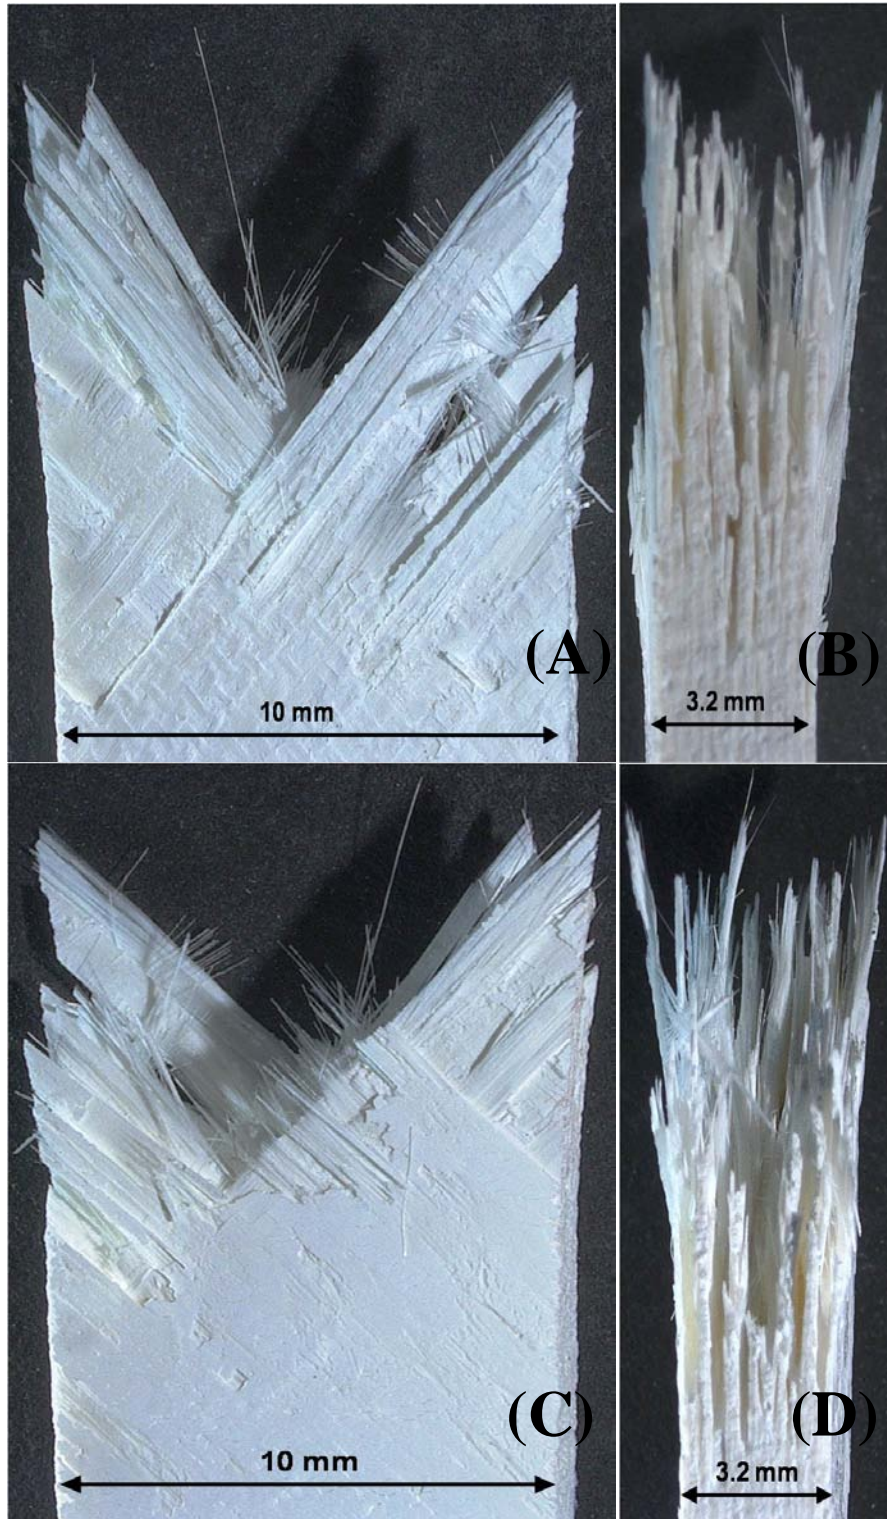
Figure 666. Fracture surface of the N720/AM specimen subjected to tensile test to failure following 100 h at 30 MPa at 1200°C in laboratory air.(a)-(c):front view,(b)-(d):side view
